# Manhole Inspection Summary

Manhole # S33AA\_022MH

Insp Date: **5/4/08 4:58 AM**

**Location** Address: **859 HOWARD ST**

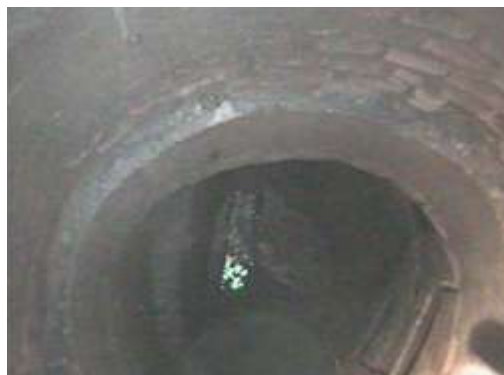
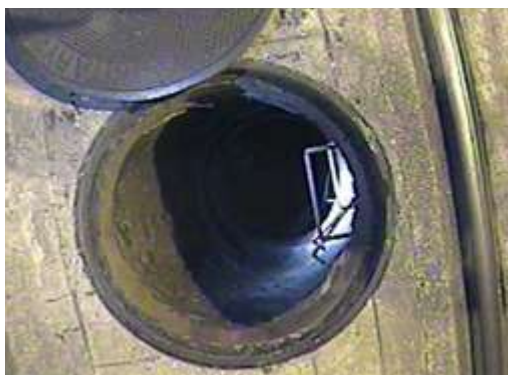
Top View

Comments **CANNOT SEE ALL OF CHANNEL FROM TOP VIEW**

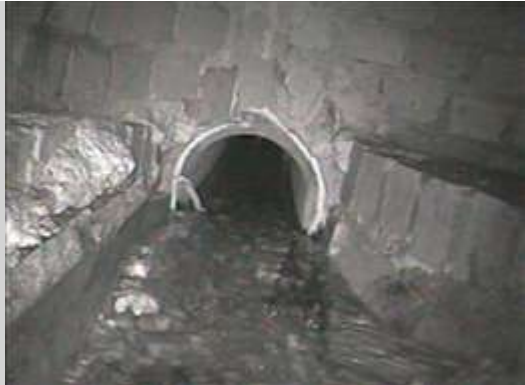
12 O'Clock Outflow

8 in. Circular Gravity Sewer  
Pipe Out @ 12 O'Clock

Pipe Height: (in.) Direct  
Pipe Material: **Clay** ☒ Pipe Lined  
Invert Depth: **17.72** (ft.) Flow Characteristics: **Slow**  
Deposits: ☒ None ☐ Mud ☐ Sludge ☐ Debris ☐ Grease  
Silt Depth: (in.) Deposits Extent:  
Infiltration: **None** Pipe Seal Cond: **Sound**

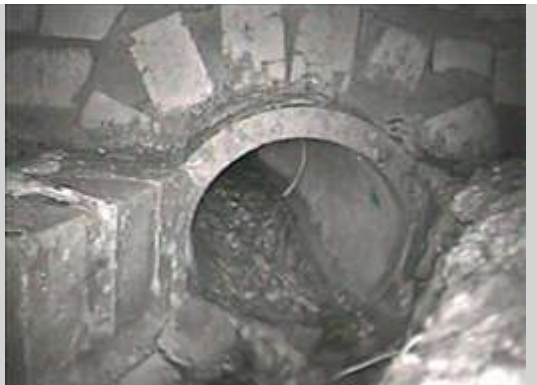
3 O'Clock Inflow

8 in. Circular Gravity Sewer  
Pipe In @ 3 O'Clock

Pipe Height: (in.) Direct  
Pipe Material: **Clay** ☐ Pipe Lined  
Invert Depth: **17.50** (ft.) Flow Characteristics: **Slow**  
Deposits: ☒ None ☐ Mud ☐ Sludge ☐ Debris ☐ Grease  
Silt Depth: (in.) Deposits Extent:  
Infiltration: **None** Pipe Seal Cond: **Sound**

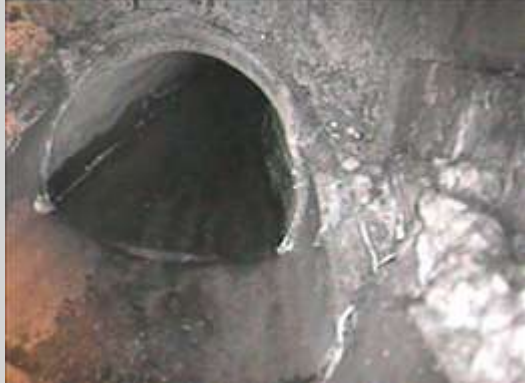
6 O'Clock Inflow

8 in. Circular Gravity Sewer

Pipe In @ 6 O'Clock

Infiltration: **Evidence** Pipe Seal Cond: **Sound**
